**Mining waste spill from the Baia Borsa processing complex in
Romania**

Assessment Mission to Hungary and Romania

UNDAC MISSION REPORT

**United Nations Environment Programme, UNEP /
Office for the Co-ordination of Humanitarian Affairs, OCHA**

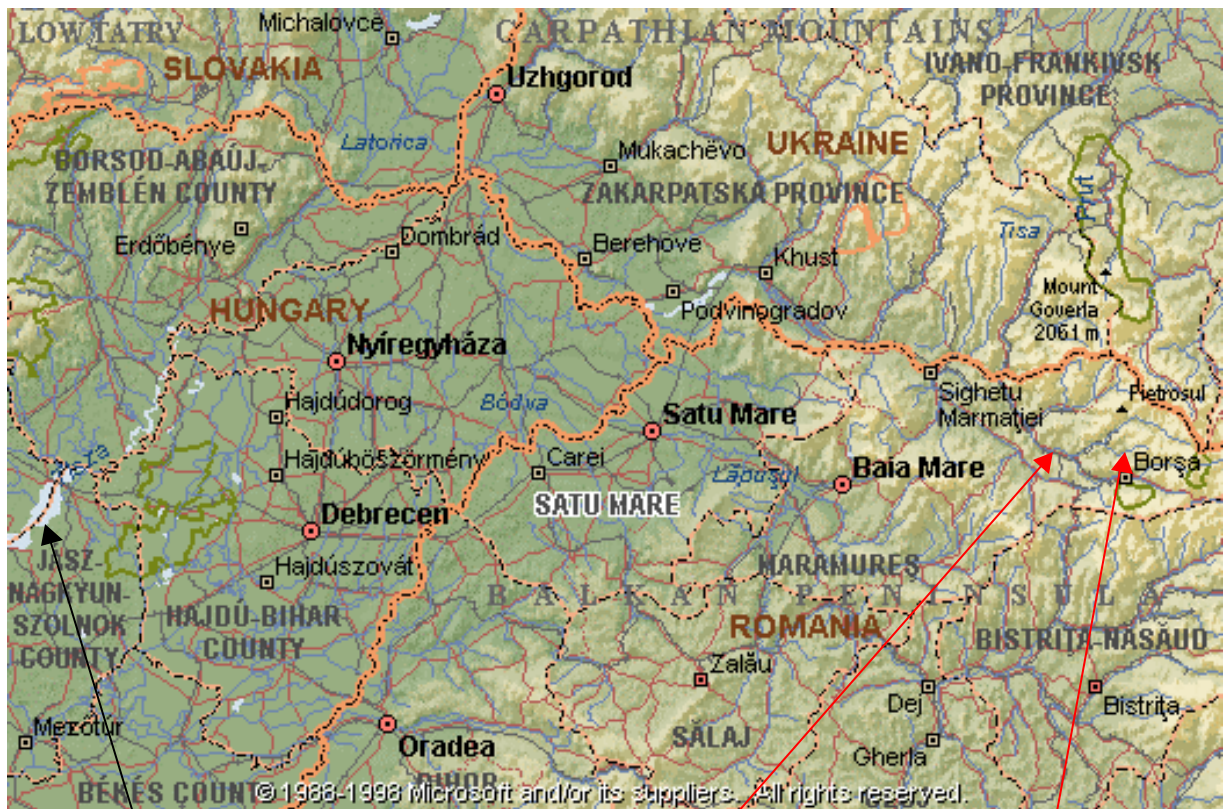
Tiszafüred

River Viseu

Accident Site

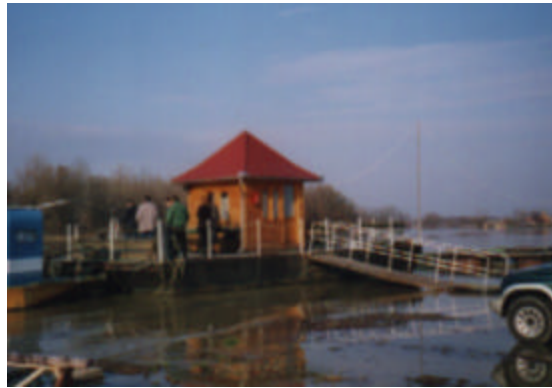
Sampling Point Tiszafüred

At the Tiszafüred measuring point, initial and provisional analysis of samples showed no increase of copper or zinc while cyanide levels were slightly higher than normal

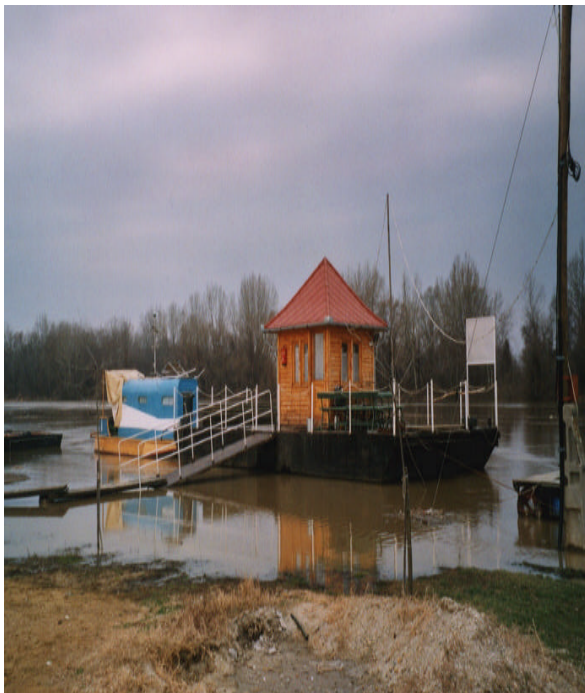
Figure 1- Sampling Platform at "Szabics" Harbour, Tiszafüred, Hungary

River km : 426
N 047° 36' 17.2"
E 020° 42' 41.1"

The water samples were taken from the swimming platform (a place with strong / good river flow).

From the River Tisza, near the town of Tiszafüred (river-km 426; Hungary), water samples were taken from a swimming port platform named "Sabics". In Trivadar (river-km 705;

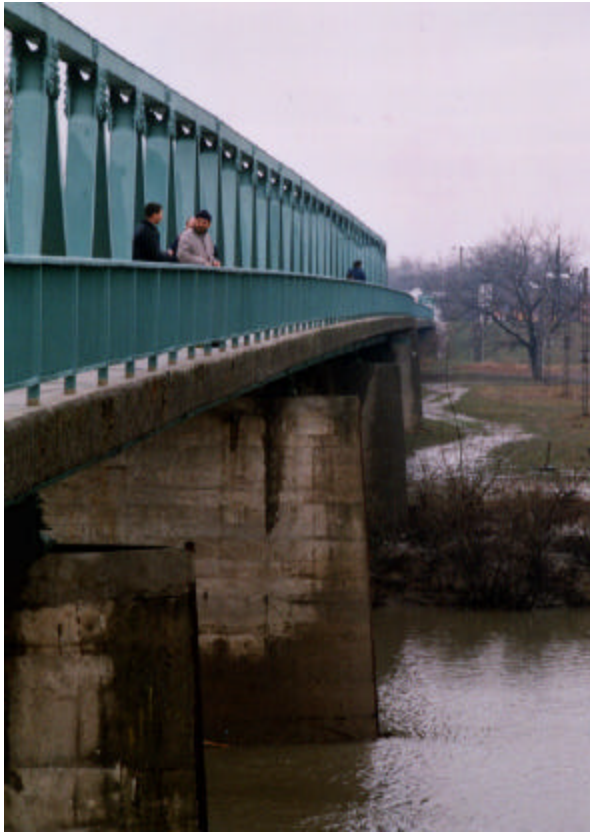
Figure 2 -Sampling from the Bridge at Trivadar, Hungary

River km : 705
N 048° 03' 35.6"
E 022° 30' 56.4"

Water samples from the bridge

Hungary), water samples were taken at the bridge (9th strutting of the bridge; from left river side). At river km 715, 718 and 720 the samples were taken from a boat. A heavy, open-topped 200 mL vessel made of steel was used for sampling. The vessel, fixed on a line, was lowered into the river water to a depth of approximately 1 metre. Each flask was rinsed at least once with river water. No filtration of the sample was performed. All samples were brought to the NC-Laboratory in Spiez (Switzerland) for a full analysis.

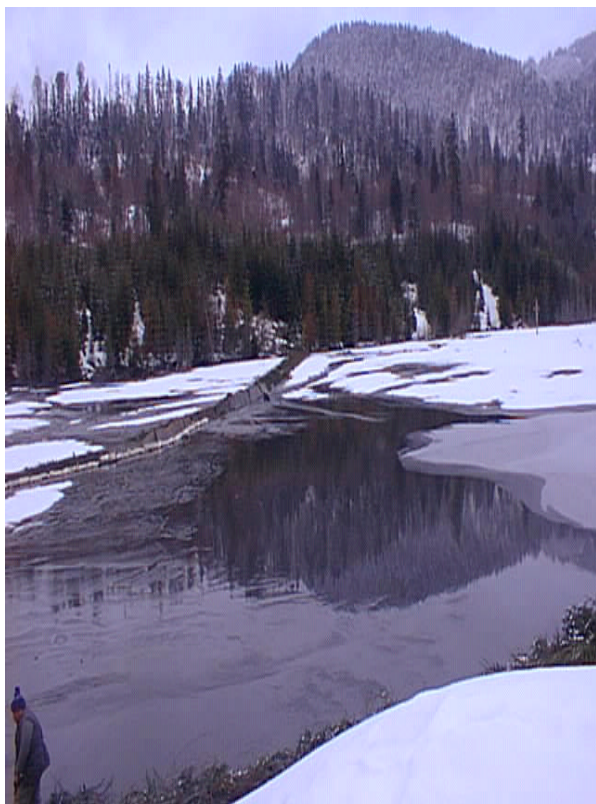
Figure 3 - Part of the pond (settling area) near the end of the pipeline Novat Dam – Baja Borsa, Romania

Pond with pipeline

Water samples (dark "Slurry")
March 16th, 2000, 05:45 p.m.

Table 12 shows the solubility of the heavy metals in the water samples near the pipeline. The analyses show high zinc, lead and sulphate concentrations.

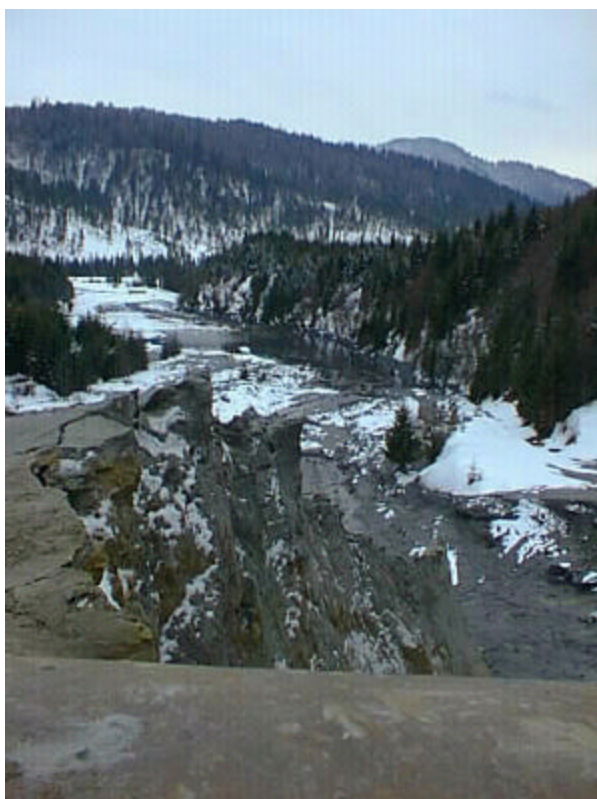
Figure 4 - View from the top of the dam near the breach

Novat - Dam at its bottom near the breach

The dam is built up with dark sandy material. In dry condition the material is stable and non-slippery. In wet condition the material changes into an unstable sludge. Sample **ZA/R-2000-026-106** was not completely analysed and is therefore not mentioned in Table 15.

With the bursting of the dam Novat on March 10, approximately 20,000 tons of heavy metal-containing waste were lost to the underlying river system, according to information obtained from Hungarian and Romanian authorities. The amount of heavy metals bound to the slick particles were found to be in the order of magnitude of 70 t lead, 150 t zinc and 40 t copper.

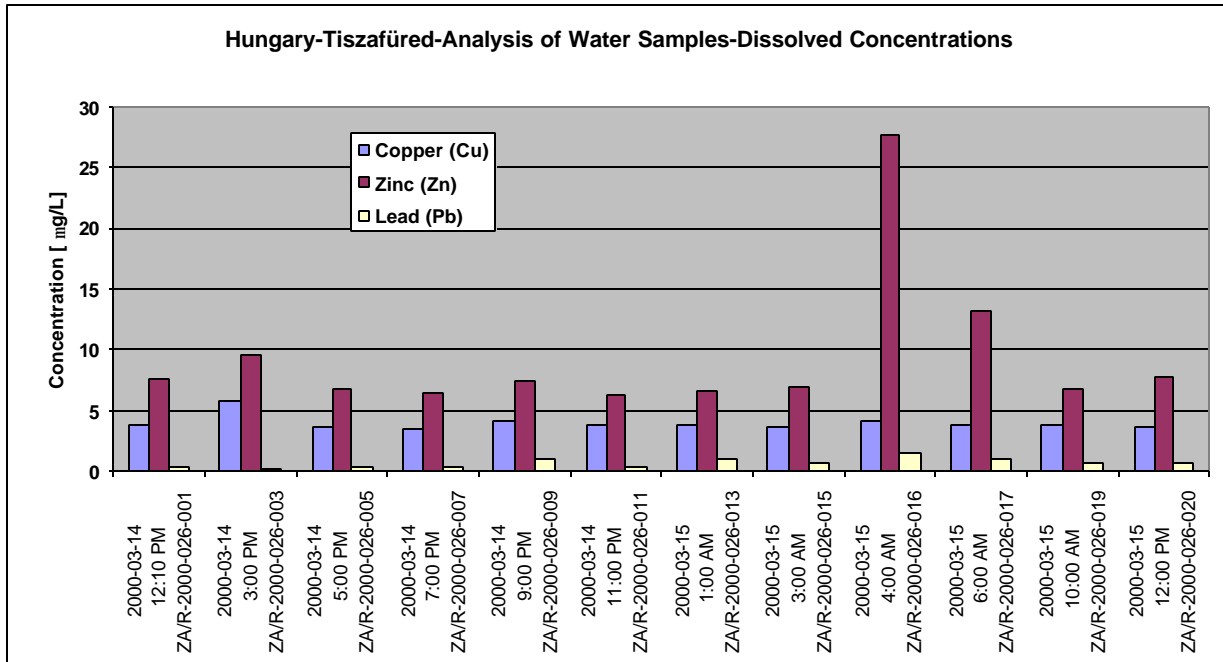
Figure 5 - Hungary-Tiszafüred-Analysis of Water Samples-Dissolved Concentrations

Figure 5 shows the soluble concentrations of zinc, copper and lead (after filtration; 0.45 µm filter) in the river water between March 14, 00:10 p.m. and March 15, 12:00 a.m.

The highest concentration of soluble zinc was detected on March 15, 2000 at 04:00 a.m.

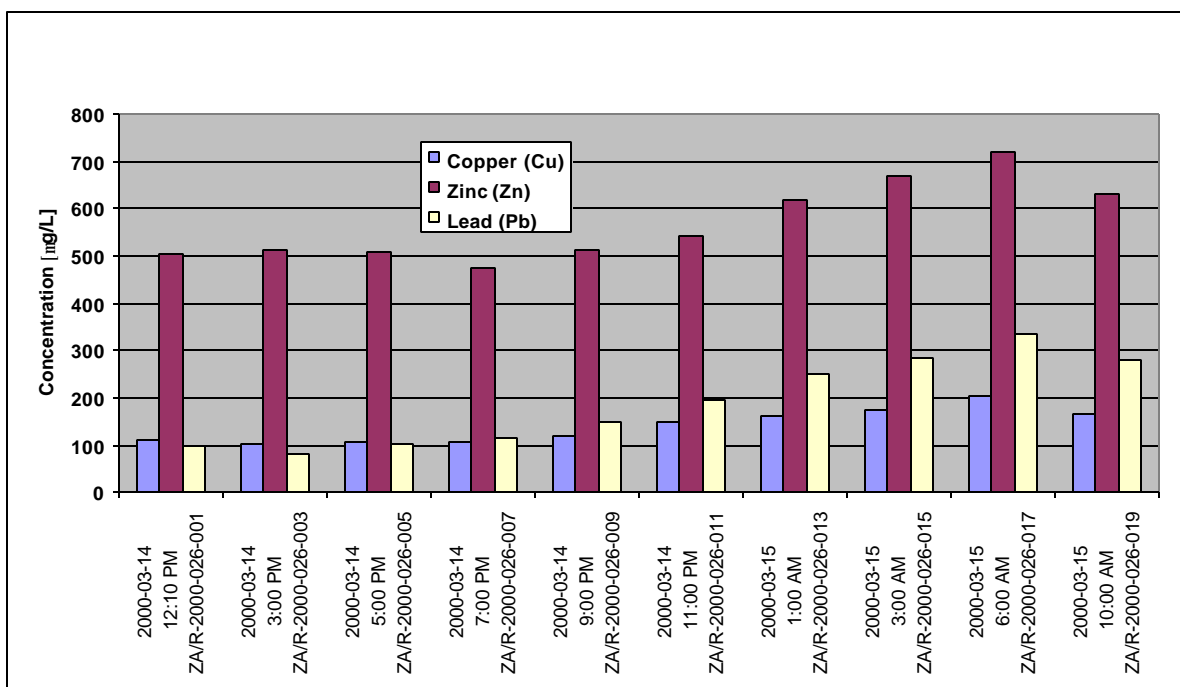
Figure 6 - Hungary-Tiszafüred-Analysis of Water Samples-Undissolved Concentrations

Figure 6 shows the insoluble concentration of zinc, copper and lead in the water between March 14, 00:10 p.m. and March 15, 10:00 a.m.

The highest concentrations of insoluble zinc, copper and lead were detected on March 15, 2000 at 06:00 a.m.

The heavy metals are mostly in an insoluble chemical modification.

Table 4 shows an integration of the histograms of Figures 1 and 2 for the period between March 14, 2000 08:00 p.m. and March 15, 12:00 a.m. The base load of the river water, based on the sample from March 14, 2000, 07:00 p.m., was subtracted in this calculation.

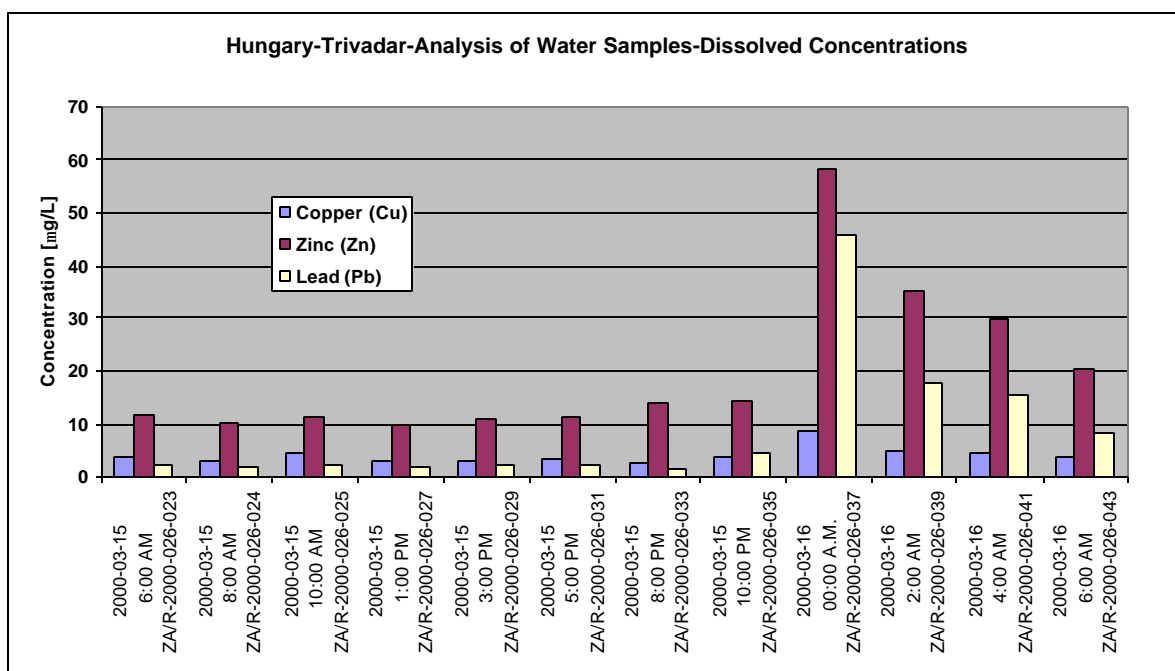
Figure 7 - soluble concentrations of zinc, copper and lead in the river water between March 15, 00:45 a.m. and March 16, 06:00 a.m.

The highest concentrations of soluble zinc, copper and lead was detected on March 16th, 2000 at 00:00 a.m.

It is interesting to know that the maximum concentrations of the dissolved heavy metals were found at both places about two hours before the highest concentrations of heavy metals bound on slick could be analysed. This effect shows the higher mobility of the dissolved impurities. The majority of the heavy metal content (in insoluble form) is incorporated in the fine-grained particles of the slick.
